Attachment To Improve Tamarisk Removal

**USDA Forest Service
Technology and Development Program
Missoula, MT**

7E72E79—Attachment To Improve Tamarisk Removal

December 2009

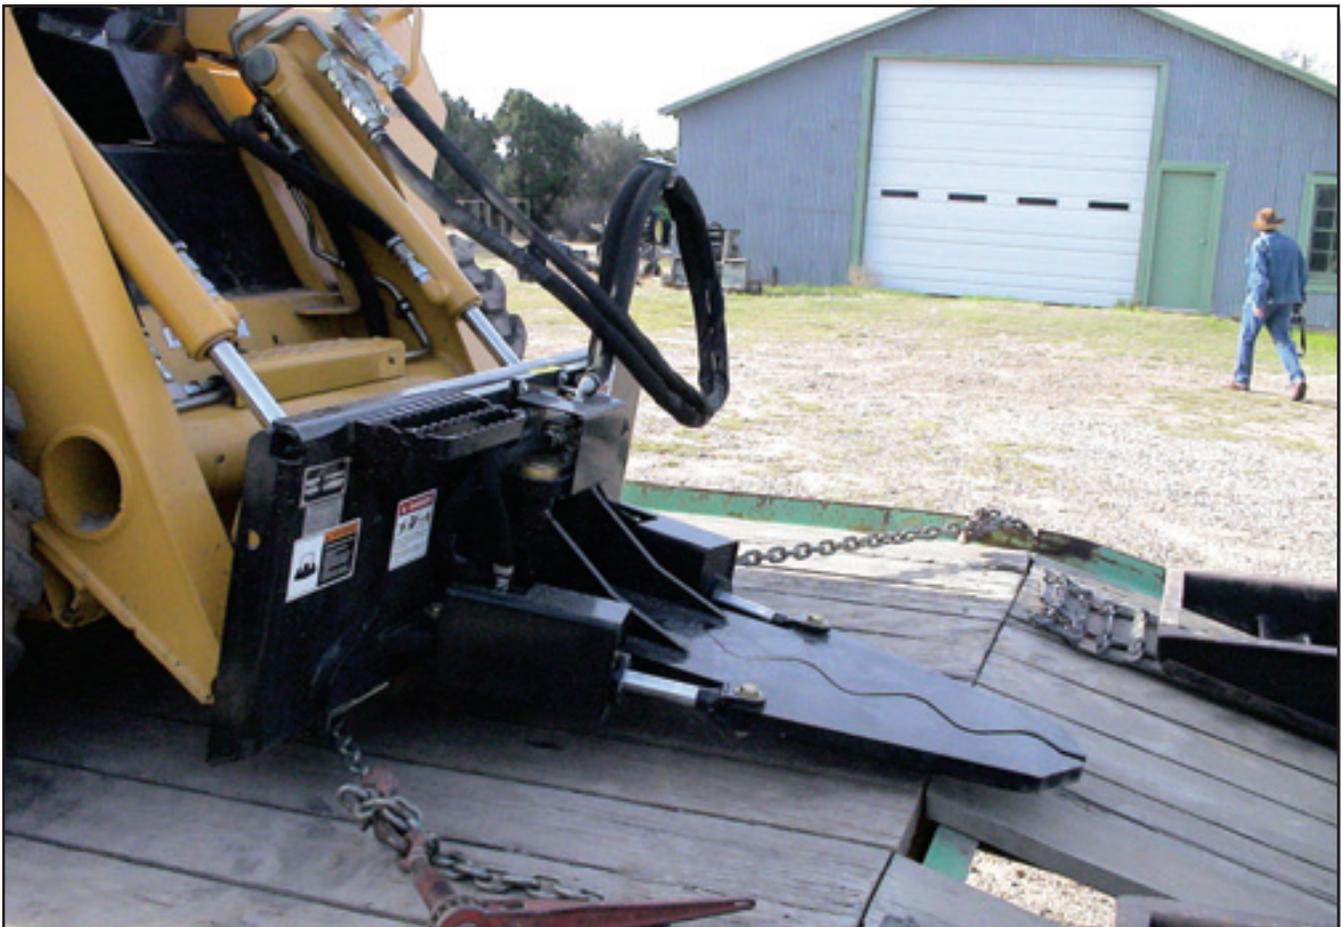
Figure 1—The Star Hill JAWZ attachment was used to pull tamarisk plants from the ground.

whether the JAWZ (figure 1) attachment could perform the task.

Some of the clumps were larger around than the JAWZ could open (34 inches maximum). In these cases, the JAWZ grabbed a portion of the tamarisk stems at or slightly below the ground line.

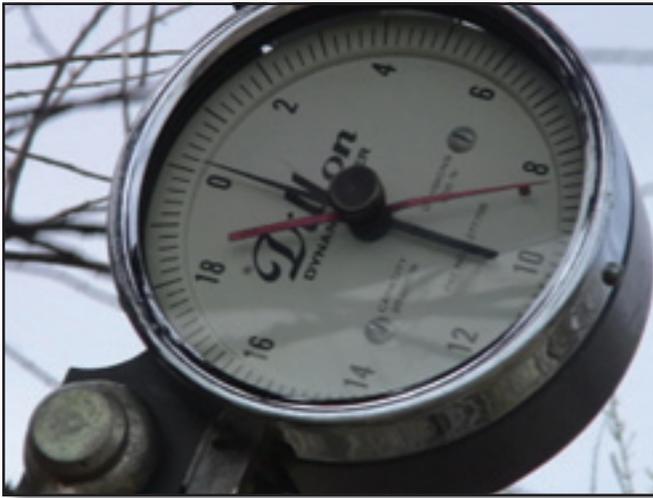
Figure 2—A Dillon 20,000-pound dynamometer used to determine how much force was needed to pull tamarisk.

To determine how much force was required to pull the tamarisk, a Dillon dynamometer (figure 2, serial No. AP505) was placed between a chain wrapped around the base of the tamarisk clump and a large, surplus military forklift designed for rough terrain (figures 3a and 3b).

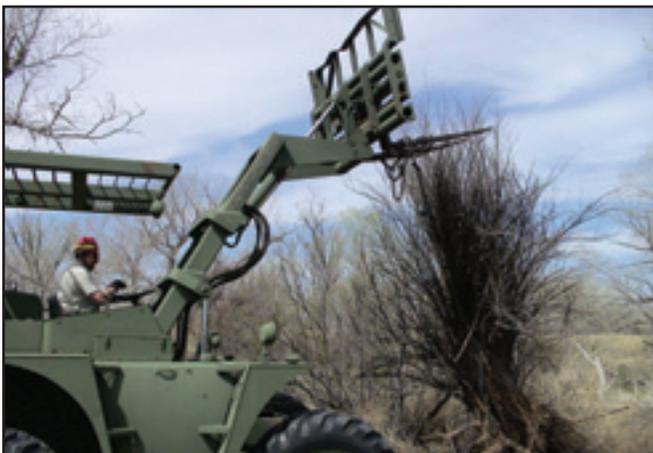
Figure 3a—A surplus military forklift designed for rough terrain was used to pull out tamarisk.

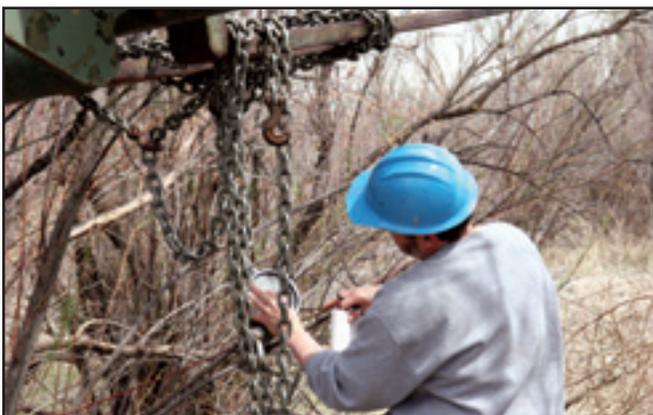
Figure 3b—Collecting pull data.

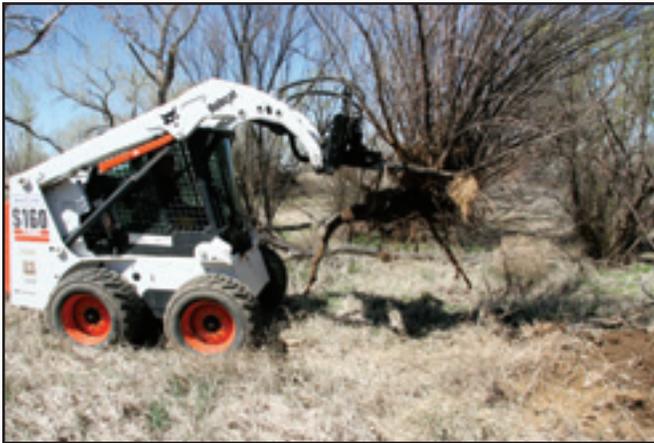
Figure 4—The Bobcat S160 skid steer loader.

The JAWZ attachment was tested on two different wheeled skid steer loaders: the Cimarron National Grassland's Bobcat S160 rubber-tired skid steer (figure 4) and a John Deere 260 skid steer (figure 5) borrowed from the Kiowa and Rita Blanca National Grasslands.

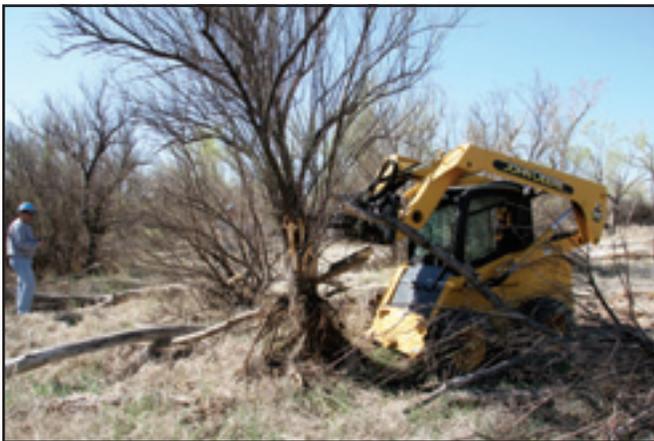
Figure 5—Tamarisk pulled up by the John Deere 260 skid steer loader. Note the size of the tamarisk's root.

The John Deere 260 has an operating capacity of 2,400 pounds, a boom breakout force of 4,800 pounds, and a tipping load of 5,000 pounds. It has 69 net horsepower and an operating weight of 8,250 pounds.

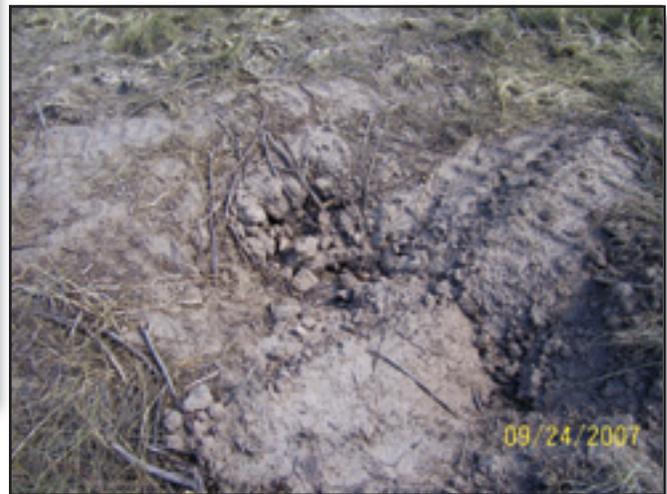
Figure 6—The hole left after a tamarisk has been pulled from sandy soil at the Cimarron National Grassland.

Holes were left after the tamarisk was pulled (figure 6). The Cimarron National Grassland employees felt that these holes would probably fill in naturally.

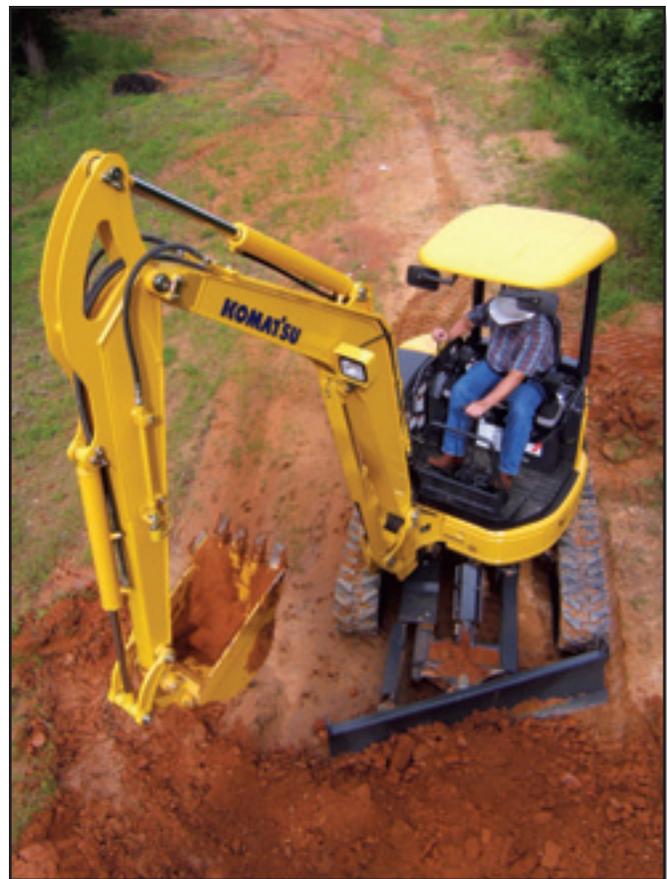
Figure 7—A Komatsu compact excavator. (Photo courtesy of Komatsu America).

Starhill located a manufacturer, Attach-All, that makes an adapter plate that will allow any skid-steer attachment to be mounted on a Komatsu PC50MR excavator (39.4 horsepower, operating weight 11,110 pounds).

The PC50MR compact excavator can apply force of 5,120 pounds at ground level (10 feet in front with standard arm length and blade down) or 2,740 pounds at ground level (10 feet to the side with standard arm length and blade down).

compromise considering equipment size, pulling capability, and general rental availability (figure 7).

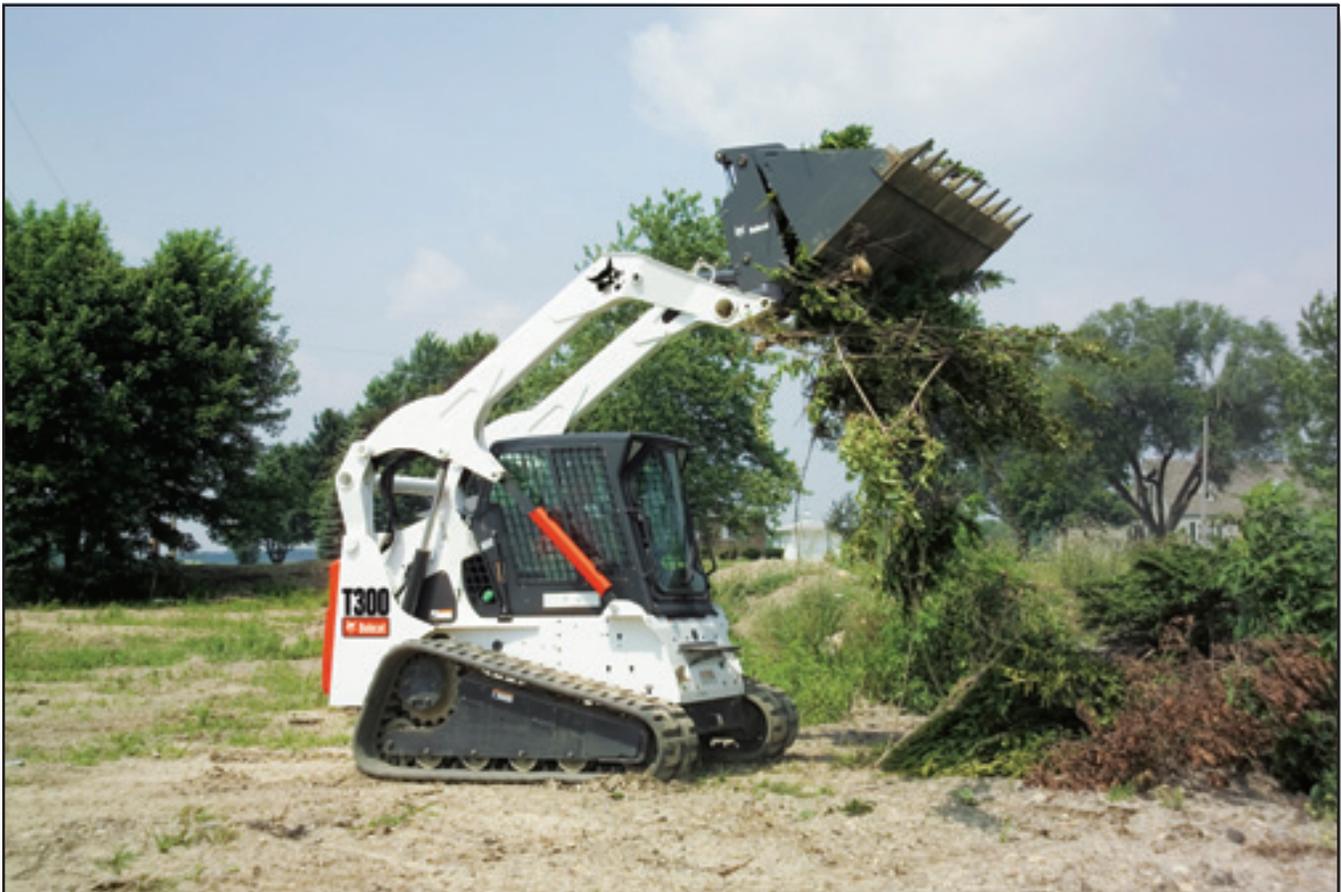
Figure 8—T300 Bobcat Compact Track Loader (Photo courtesy of Bobcat Co.). No photos with the JAWZ mounted on the T300 were available.

A Bobcat T300 compact tracked loader (figure 8) was rented to replace the PC50MR compact excavator. The T300 has rubber tracks for improved maneuverability and flotation. The T300 compact tracked loader has 81 horsepower, a boom breakout force of 6,700 pounds, and a rated lifting capacity of 3,000 pounds.

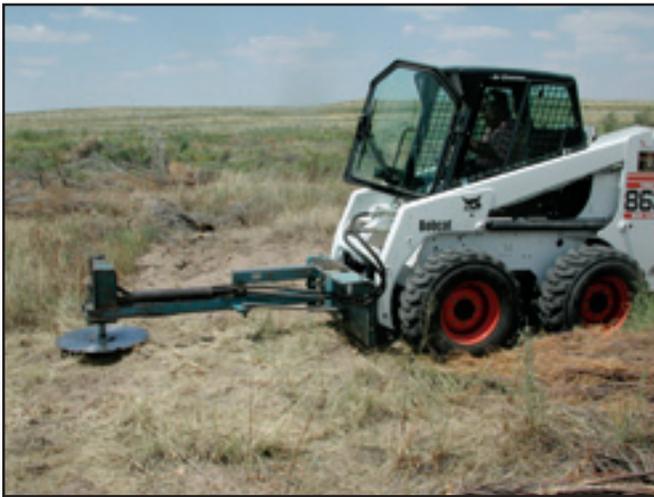
Figure 9a—A Bobcat brush saw mounted on a skid steer loader.

One eradication method now used on the Cimarron National Grassland involves cutting tamarisk. Figures 9a through 9d show how the Cimarron National Grassland cuts tamarisk with a rigid Bobcat brush saw mounted flush with the ground on a skid steer.

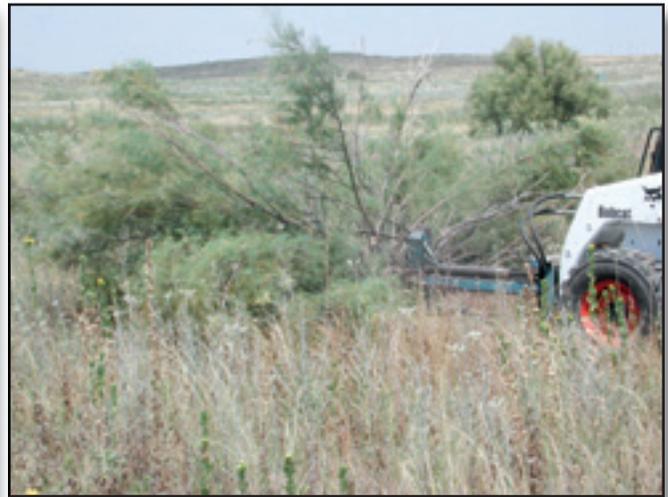
Figure 9c—The Bobcat brush saw being used to cut tamarisk.

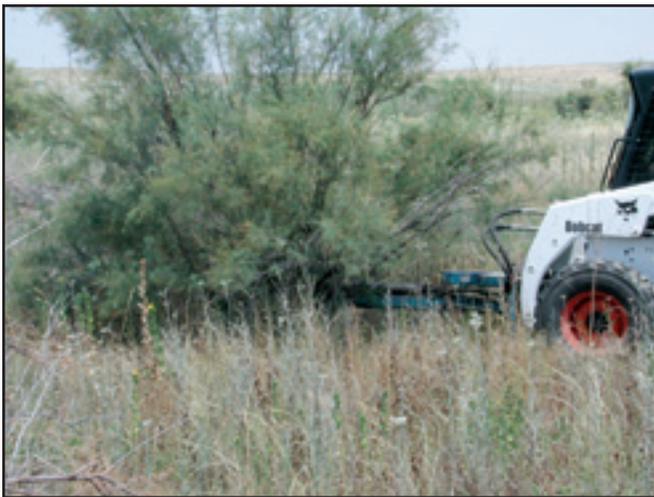
Figure 9b—The skid steer loader equipped with a Bobcat brush saw approaches a tamarisk plant.

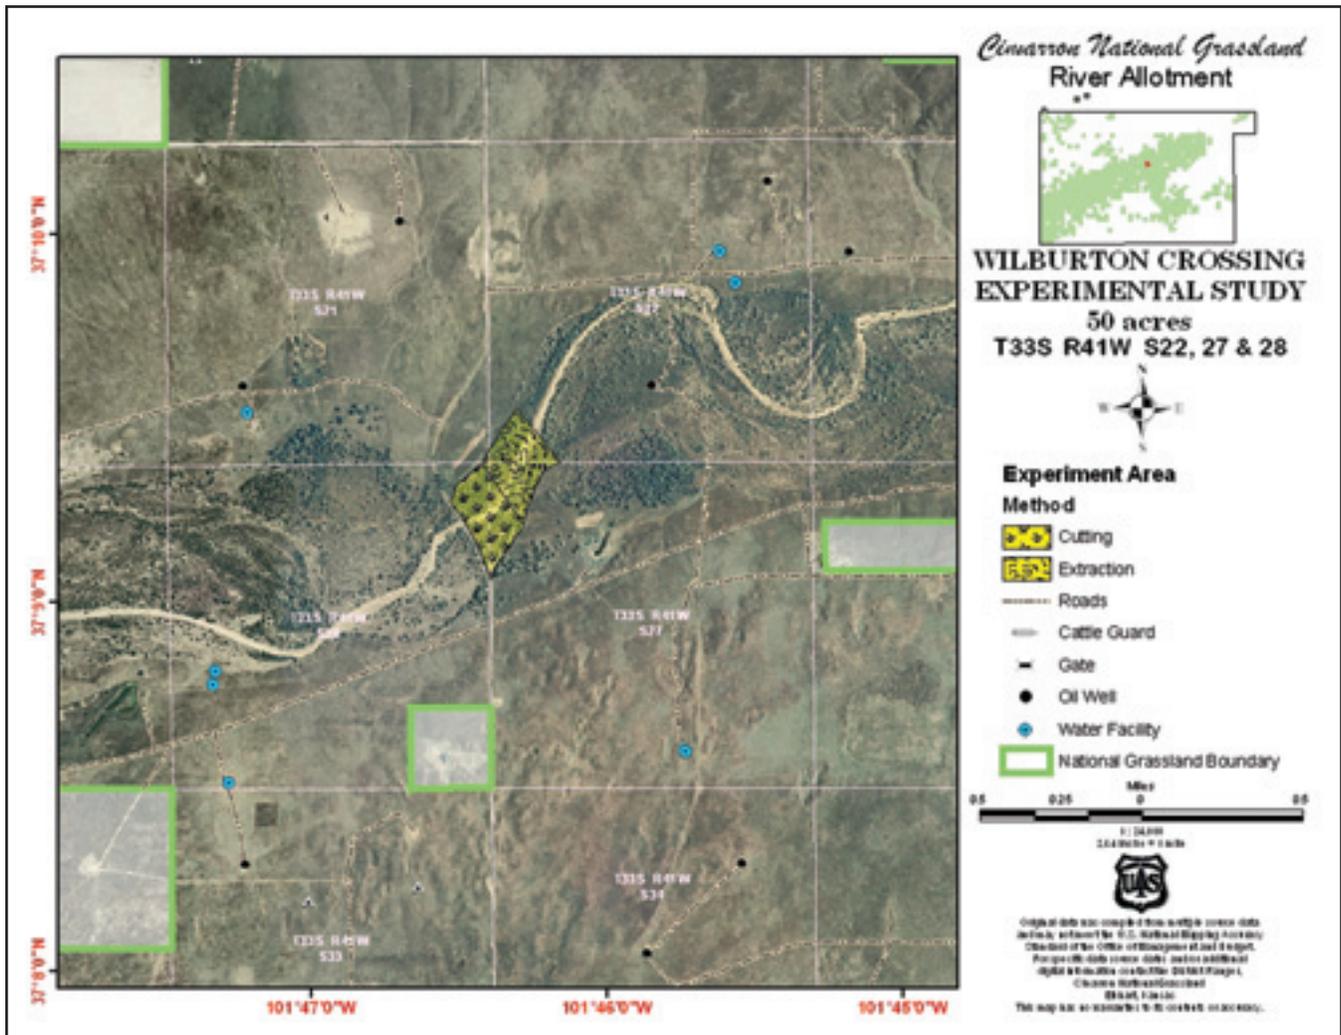
Figure 10—The study site at the Cimarron National Grassland was divided into a cutting plot and an extraction (or pulling) plot.

The study site (divided into two study plots) was east of the Cimarron River crossing on Morton County Road 16 (figure 10). Both study plots ran north and south across the river. Cimarron National Grassland employees flagged the plots with surveyor's tape. The tamarisk infestation was heavier

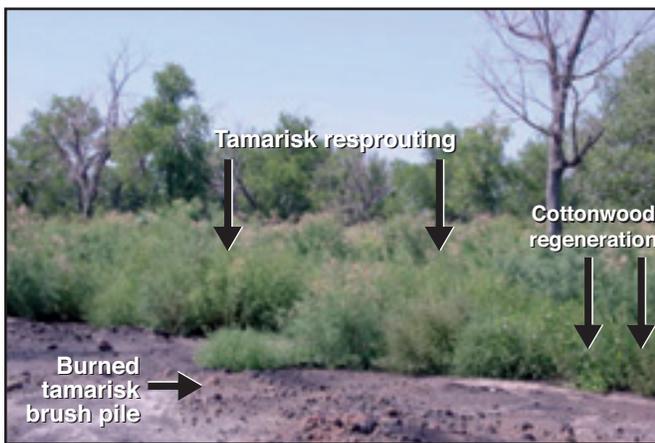
Figure 15—An overview of the study site where tamarisk trees were cut (September 4, 2008). The bare ground is where piled tamarisk was burned.

Tamarisk resprouted abundantly from stumps when it was cut with a brush saw. The height of the tamarisk sprouts ranged from 3 feet to about 6 feet (figure 15). There were few sprouts in the pulling plot where tamarisk was extracted with the JAWZ attachment. The height of the tamarisk sprouts there ranged from 1 foot to about 5 feet (figure 16).

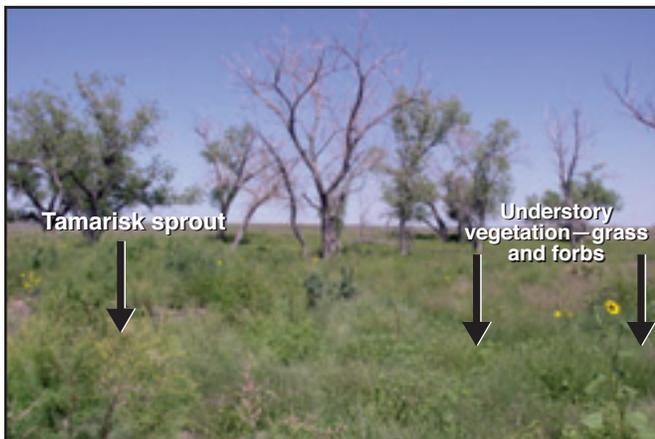
Figure 16—An overview of the study site where tamarisk trees were pulled (September 4, 2008).

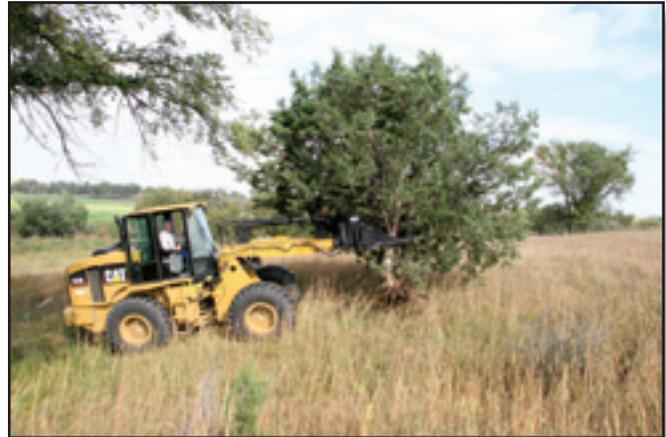
Figure 17a—Star Hill Super JAWZ on a Caterpillar 924 removing a tree (Photo courtesy of Starhill Solutions, Inc.).

The Super JAWZ could pull large clumps of tamarisk from drier soils, but doing so would risk snapping the tamarisk off at the ground line. If that happens, additional sprouting is likely. Rubber-tired machines will not be able to maneuver in sandy river bottom soils as well as machines mounted on tracks.

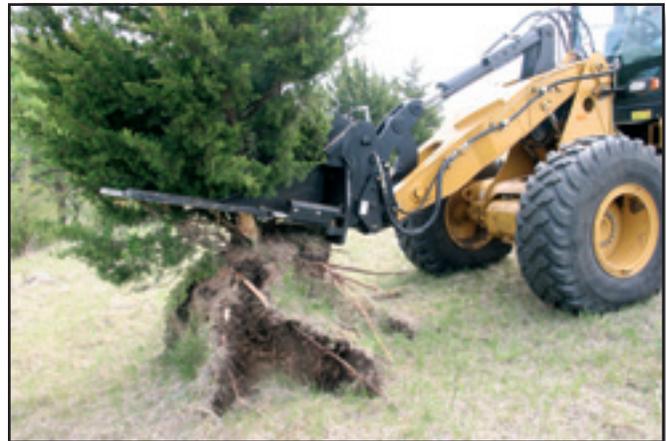
Figure 17b—Star Hill Super JAWZ with adapter for Caterpillar 924 (Photo courtesy of Starhill Solutions, Inc.).

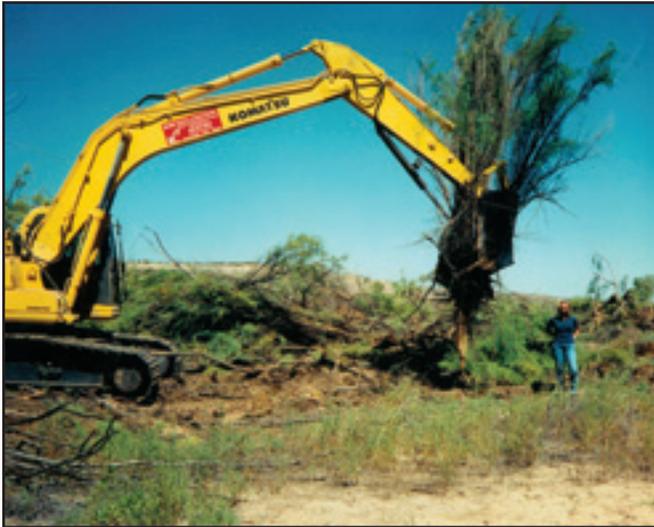
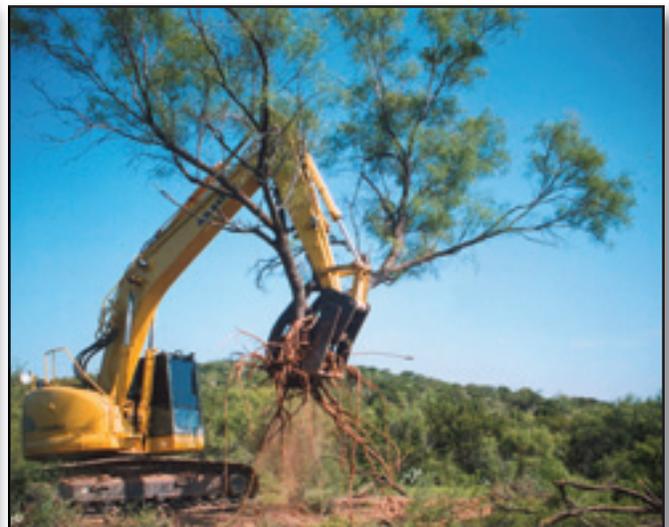
Figure 18a—Boss Reclamation equipment at work (Photo courtesy of Boss Reclamation, LLC).

Figure 18b—Boss Reclamation equipment at work (Photo courtesy of Boss Reclamation, LLC).

The Cimarron National Grassland is interested in using a full-sized excavator to remove tamarisk. Boss Reclamation, LLC, based in Texas, has a proprietary excavator digging head (figures 18a and 18b) that has removed larger tamarisk and other invasive tree species. The Cimarron National Grassland would like companies with this type of equipment to bid on the Cimarron River vegetation treatment project, during which tamarisk would be removed on 196 acres.
